**Control of creeping water primrose
Ludwigia grandiflora
at Breamore Marsh, in New Forest District, Hampshire, UK**

**A report prepared on behalf of RINSE
(Reducing the Impact of Non-native Species in Europe)**

**Report prepared by
Hampshire and Isle of Wight Wildlife Trust
April 2013**

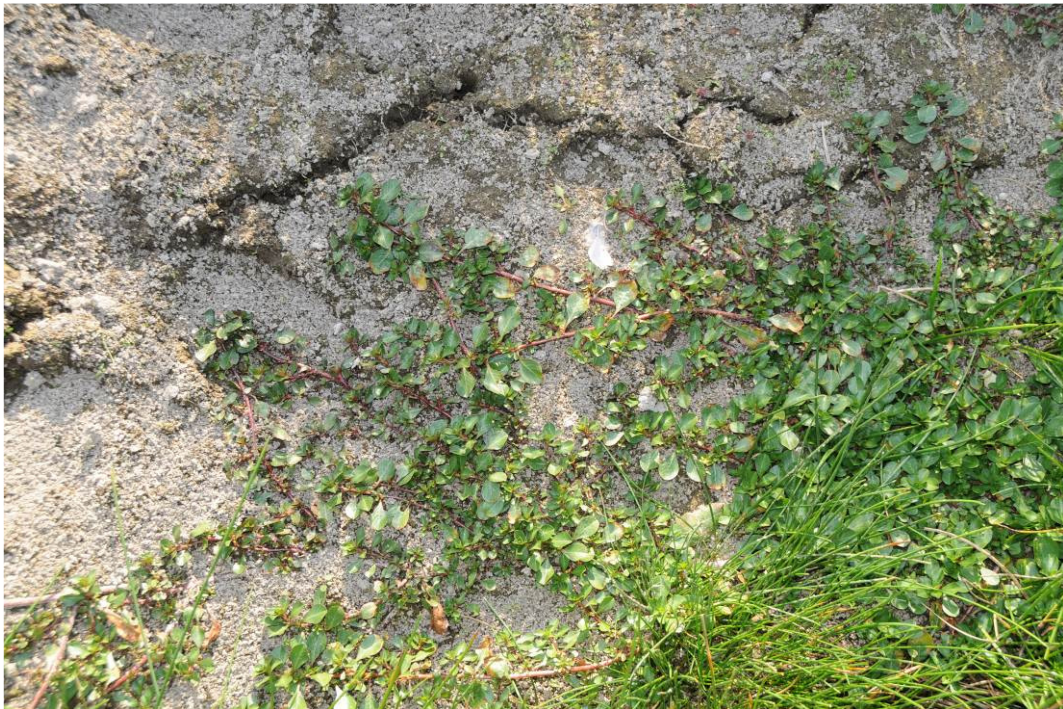
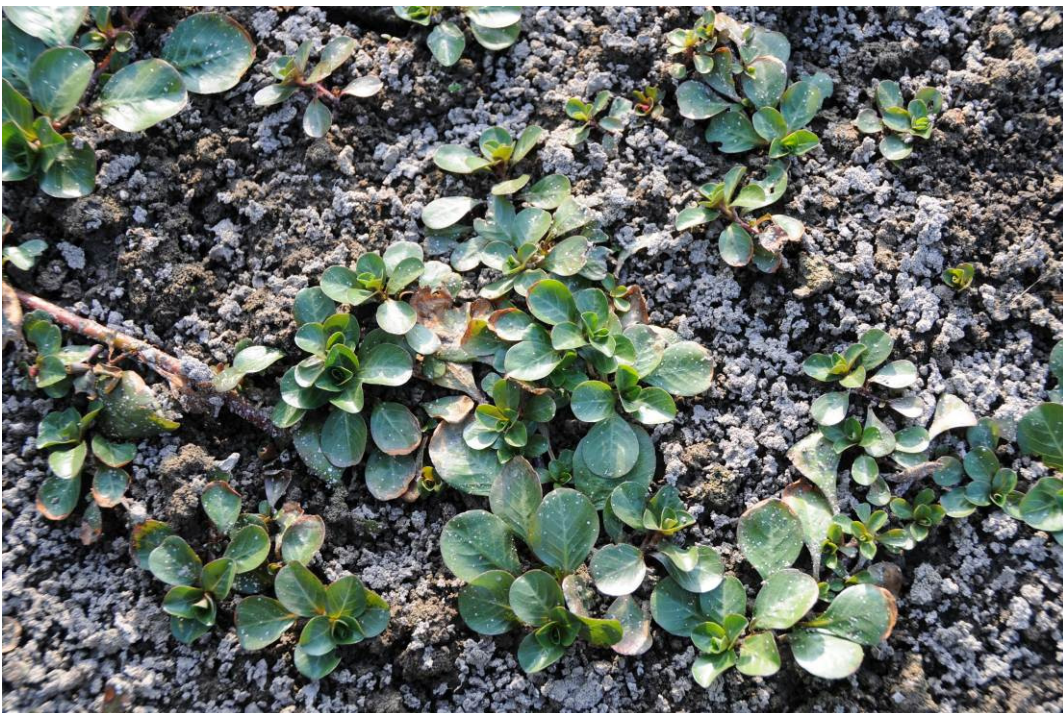
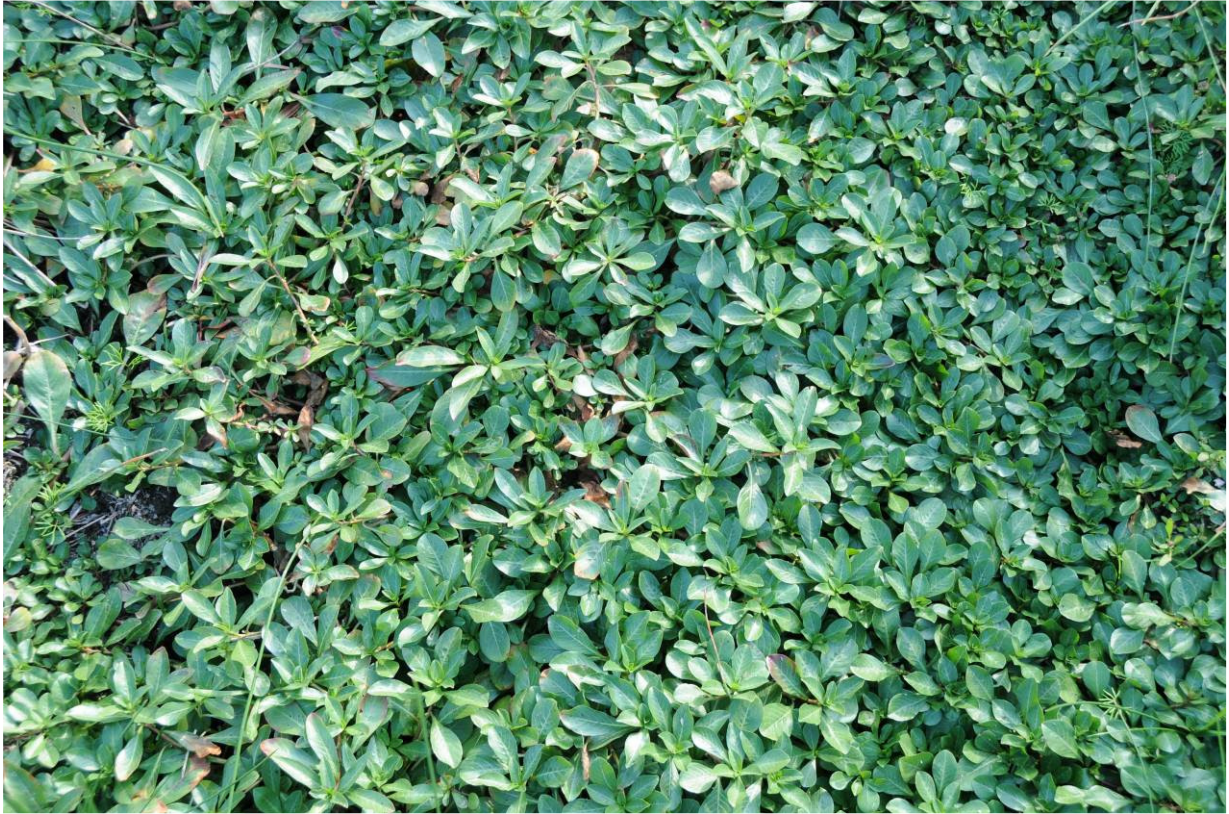
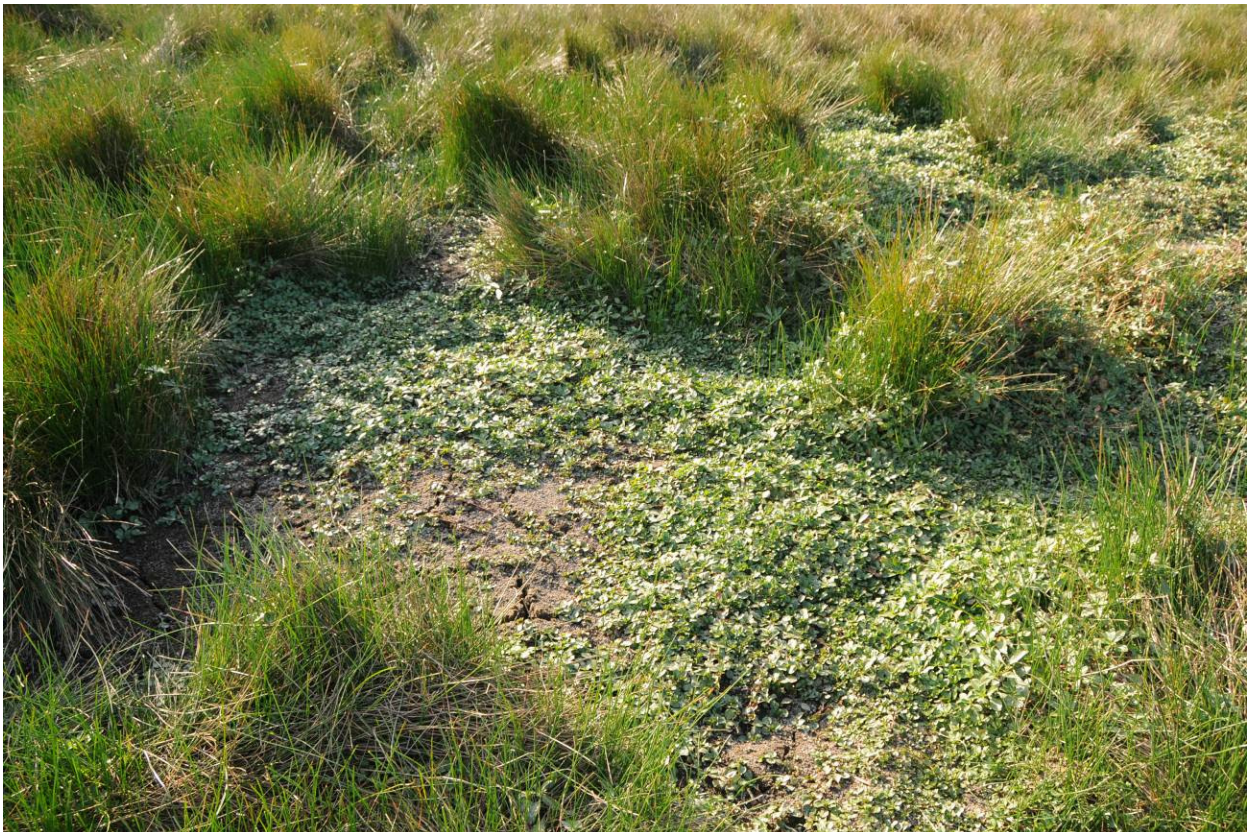
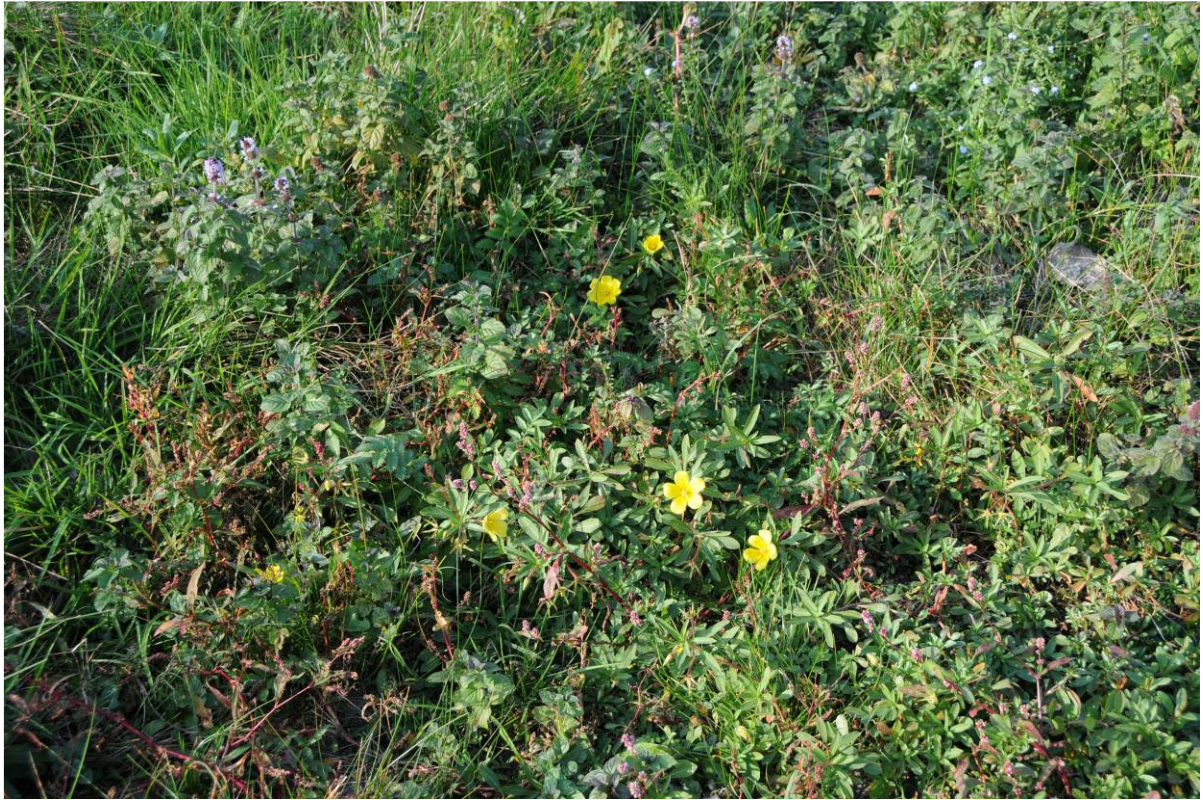
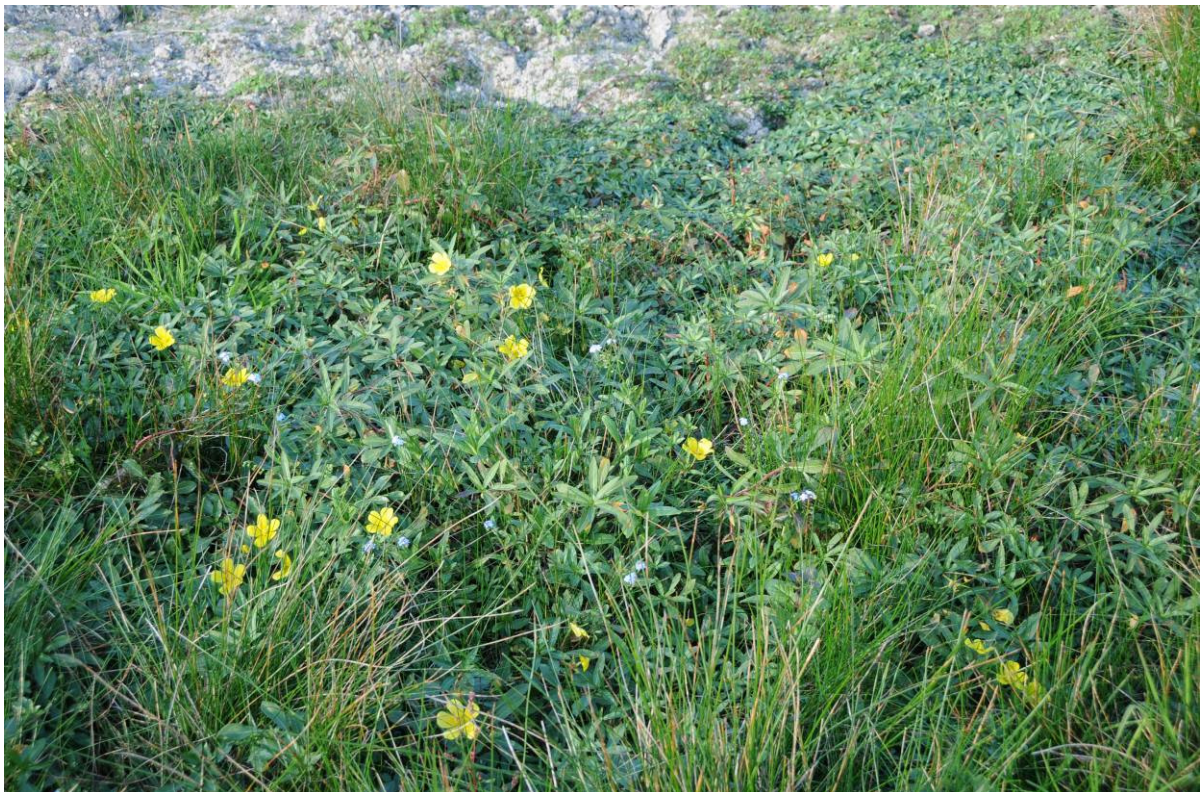
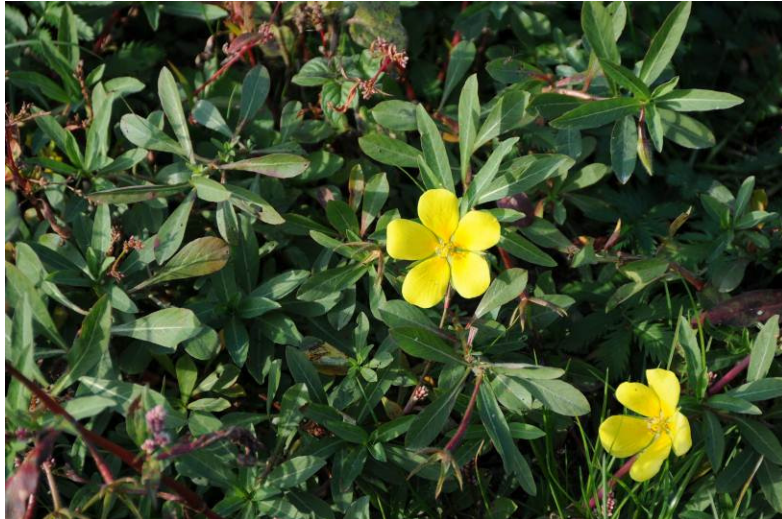
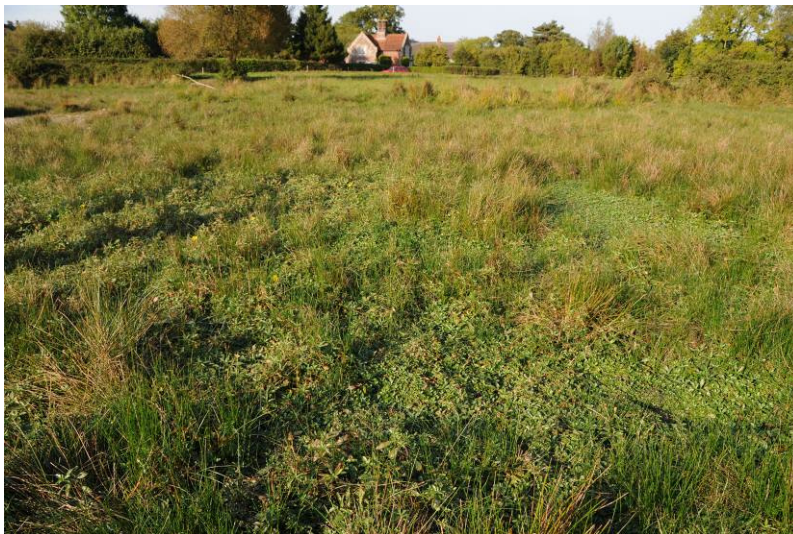
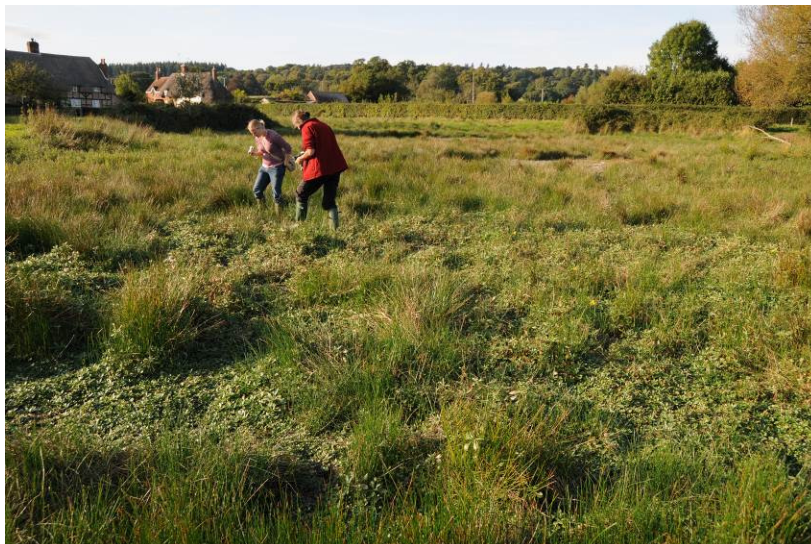
The *Ludwigia grandiflora* was dominant over large parts of Round Pond, spreading across bare mud, forming dense mats of foliage and flowering amongst other vegetation as shown in the following photographs:-

Ludwigia grandiflora photographed at Round Pond on 1 October 2009
(photographs: Trevor Renals)

Ludwigia grandiflora at Round Pond, Breamore Marsh on 1 October 2009
(photographs: Trevor Renals)

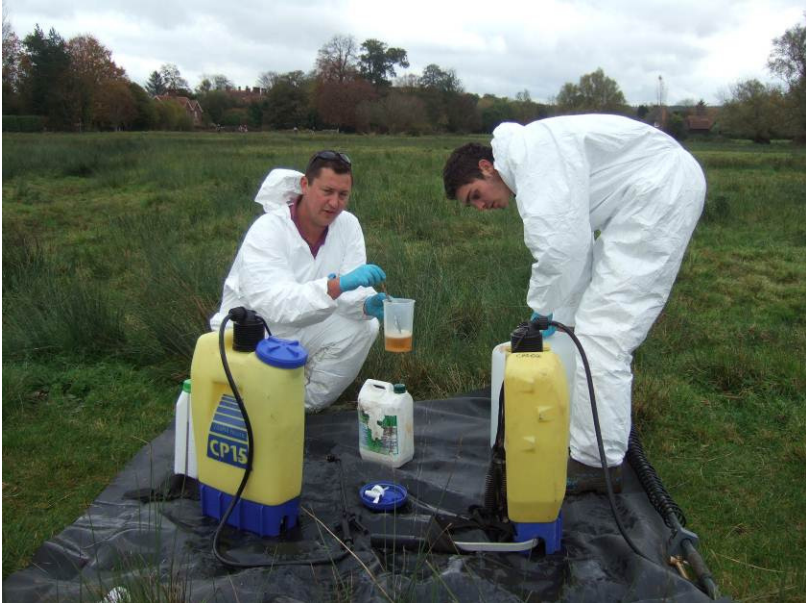
Scott Rice and George Hyde of Kingcombe Aquacare Ltd preparing the herbicide for treatment of creeping water primrose at Breamore Marsh SSSI on 29 October 2009

Kingcombe Aquacare Ltd planned to undertake the first herbicide treatment on Tuesday 6 October 2009 but unfortunately the weather that day was very wet and the work had to be postponed until 29 October 2009 as herbicide treatment is only effective in dry conditions.

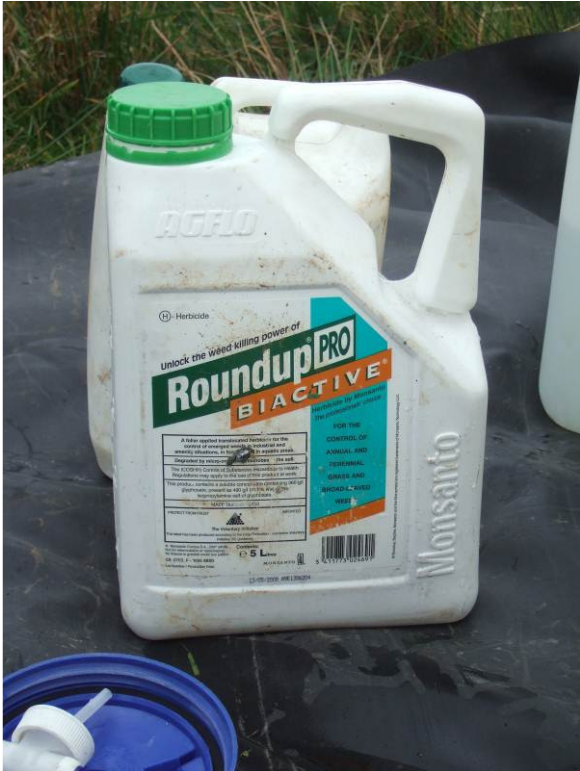
The creeping water primrose at Breamore Marsh was treated with the Glyphosate-based herbicide Roundup Pro Biactive and an adjuvant called 'Topfilm'

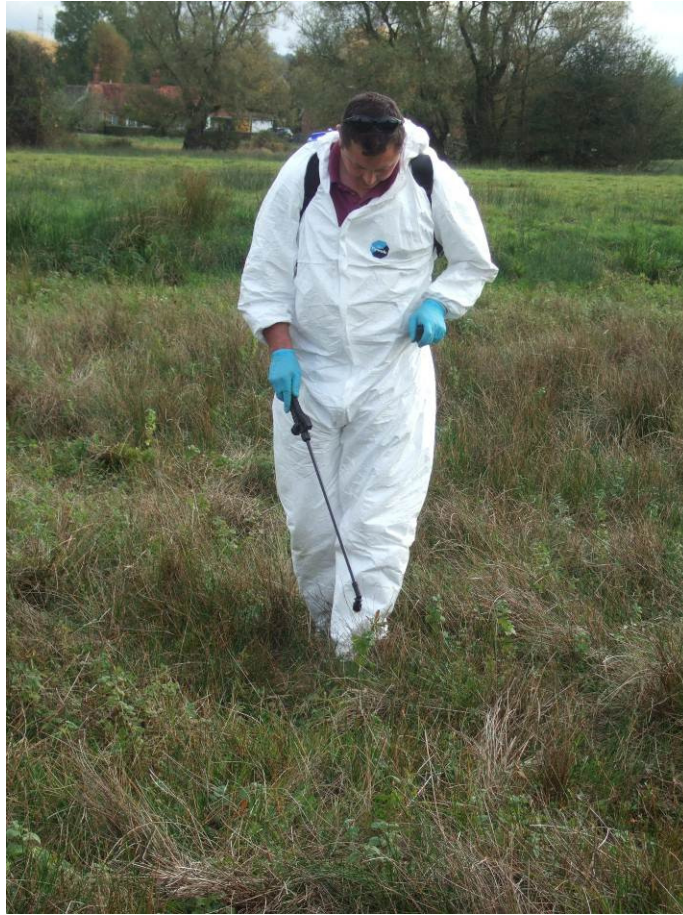
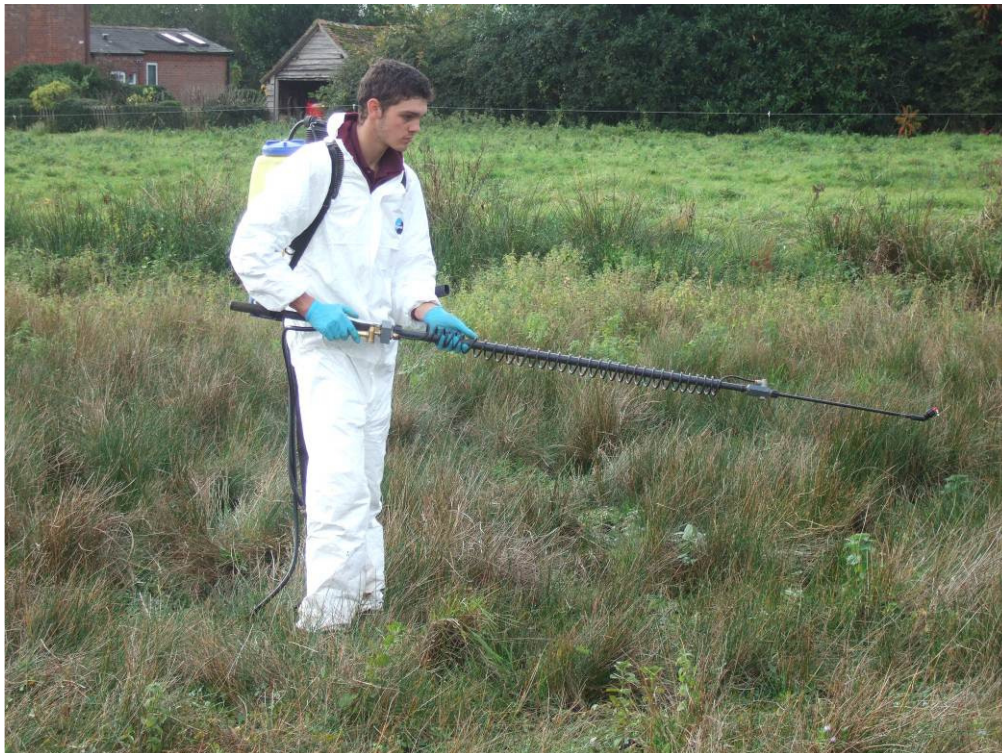
Herbicide treatment being undertaken at Breamore Marsh on 29 October 2009

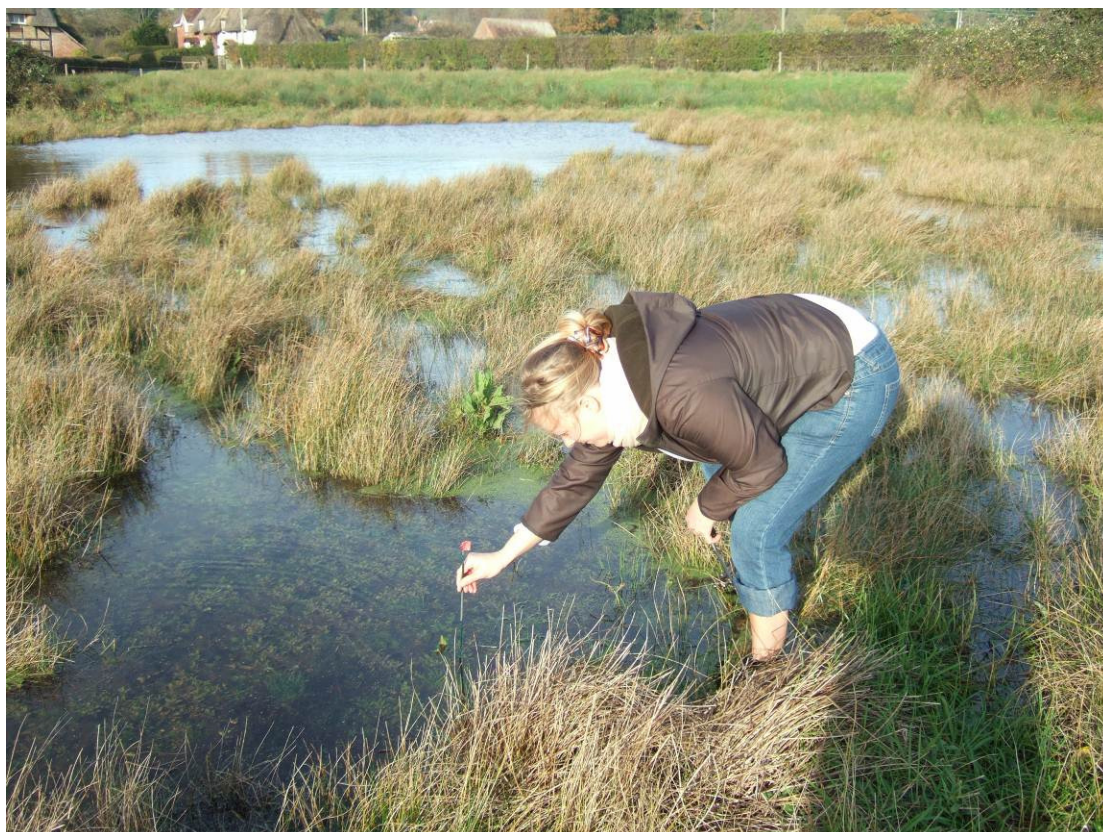
On 19 November 2009 the New Forest Non-Native Plants Officer and a representative of Plantlife visited Round Pond to mark out the creeping water primrose which required further herbicide treatment. 'Flags' made from red adhesive tape were attached to the top of garden canes to mark out areas where further herbicide treatment was necessary. Although some patches of creeping water primrose had clearly been affected by the herbicide treatment, there was evidence of fresh, new growth from many of these patches.

Sophie Thomas of Plantlife at Breamore Marsh on 19 November 2009 marking out areas where more herbicide treatment is required

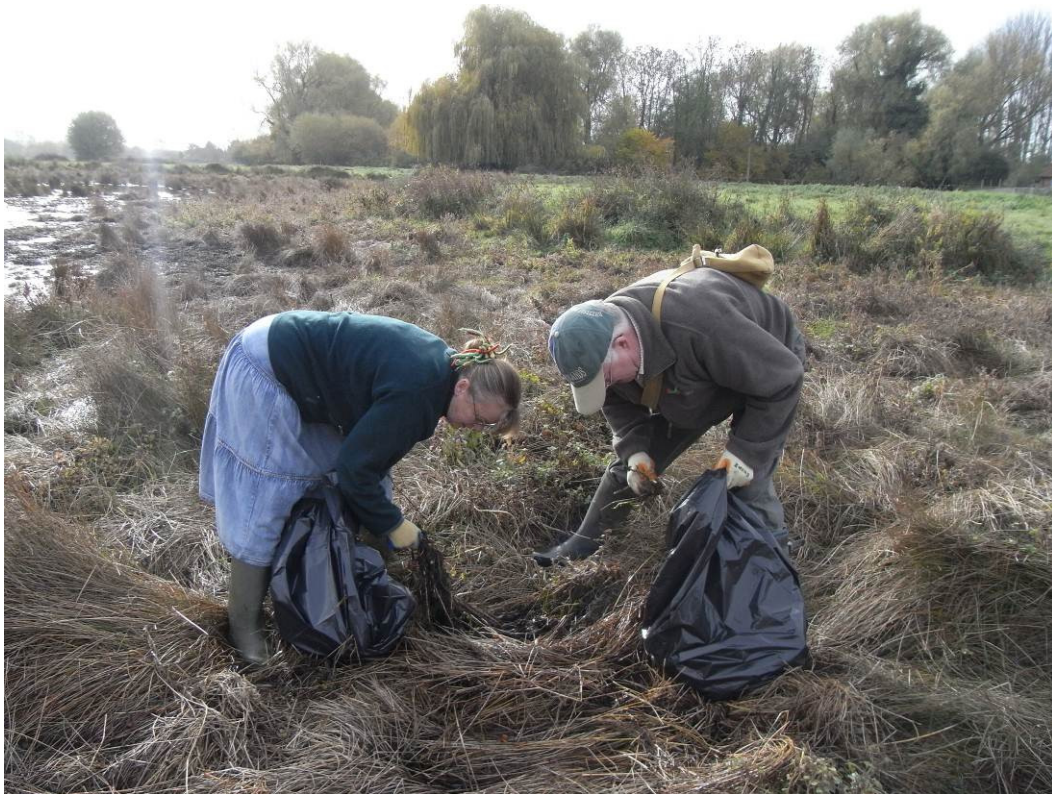
Local residents who helped the project officer hand-pull *Ludwigia grandiflora* at Round Pond on 3 November 2010

Following the volunteer work party the project officer concluded that hand-pulling was probably an effective method to help check the spread of the *Ludwigia* in the vicinity of the outlet but considered that more drastic measures, such as scraping out the pond, would be required to eradicate the *Ludwigia*. It appeared that the herbicide treatment undertaken at Round Pond had effectively killed *Ludwigia* plants in areas where there was no rush *Juncus* spp; the project officer therefore considered that scraping out the pond would help increase the effectiveness of future herbicide treatments as a reduction in rush *Juncus* spp cover would increase the amount of chemical coming into contact with the *Ludwigia* foliage. If the *Juncus*-dominated vegetation could be removed, any *Ludwigia* plants which had not been killed by the herbicide treatment could then more easily be seen and controlled with a regular hand pull.

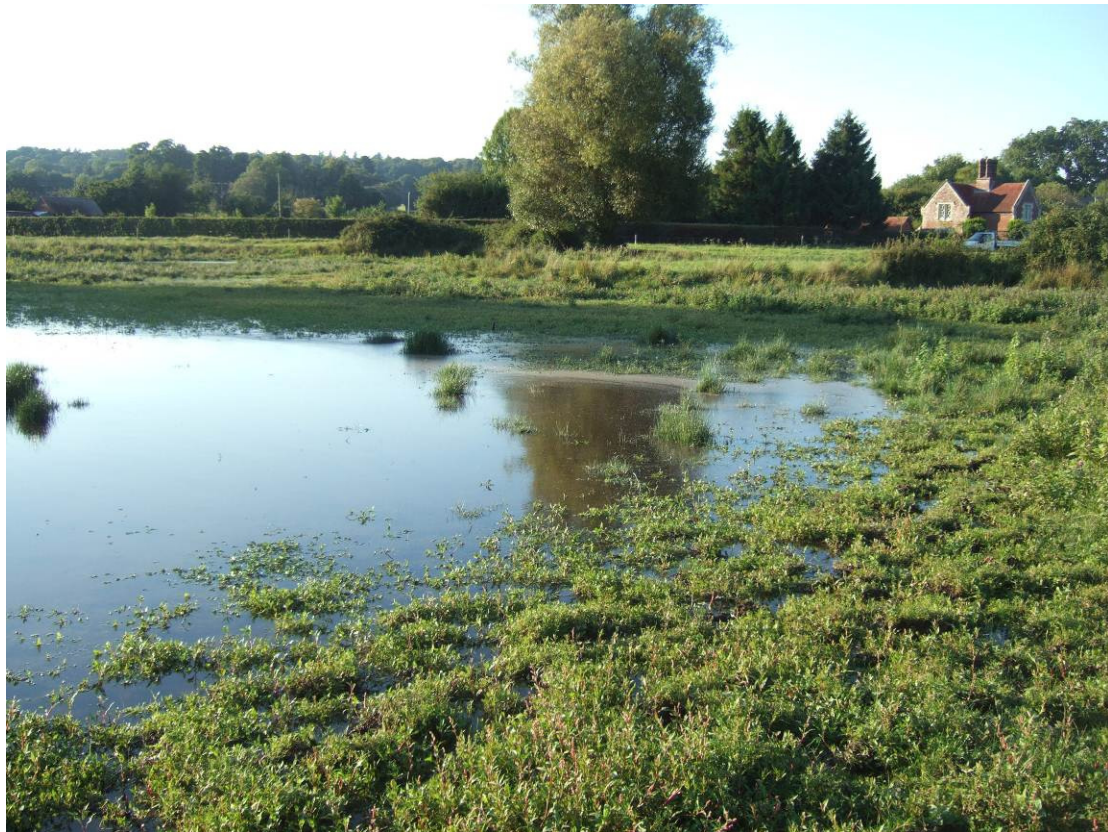
Torrential rain fell in Hampshire on 18 August 2011. When this photograph was taken on 19 August 2011, water levels in Round Pond were uncharacteristically high for this time of the year.

The unfavourable weather conditions prevented any herbicide treatment being undertaken during August 2011 and it was then not possible for the pond to be treated until September. By this time, the warm wet summer weather had caused the population of creeping water primrose to explode. However due to the drier weather earlier in the season only one or two upright flowering stalks were seen.

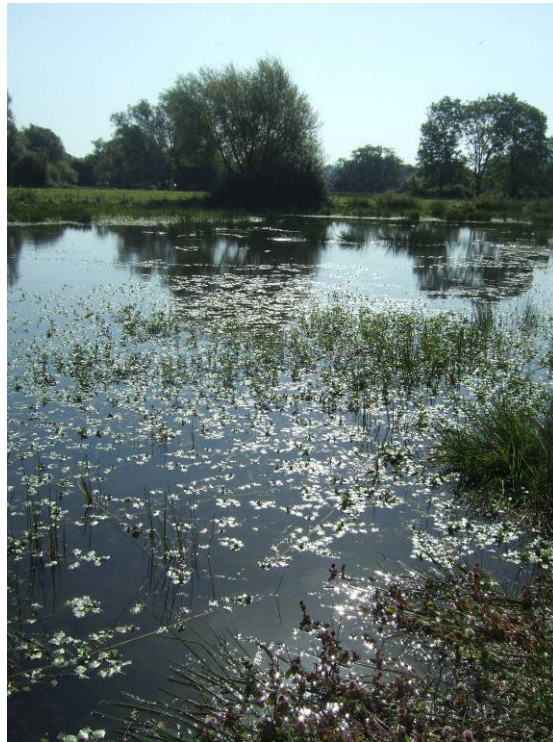
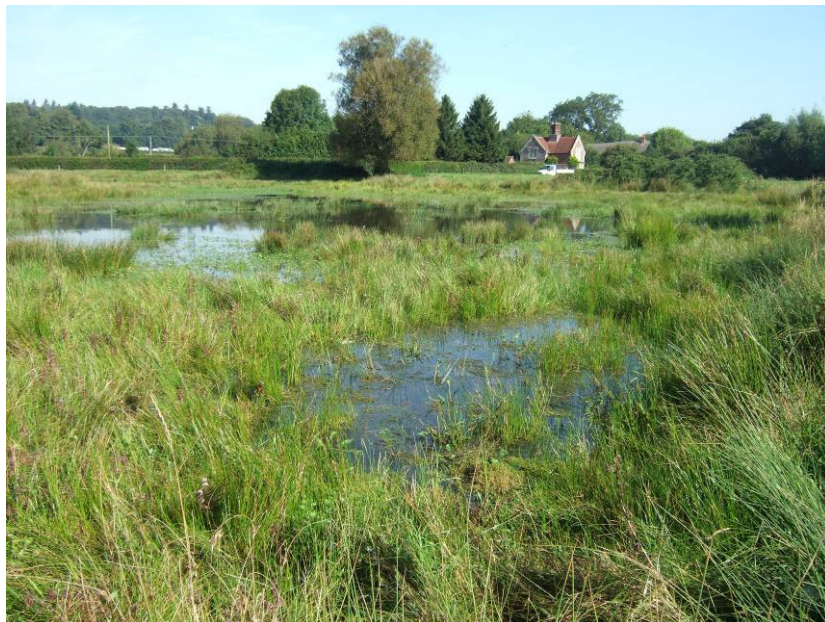
Round Pond on 9 September 2012. Water levels remained too high for herbicide treatment to be undertaken during 2012.

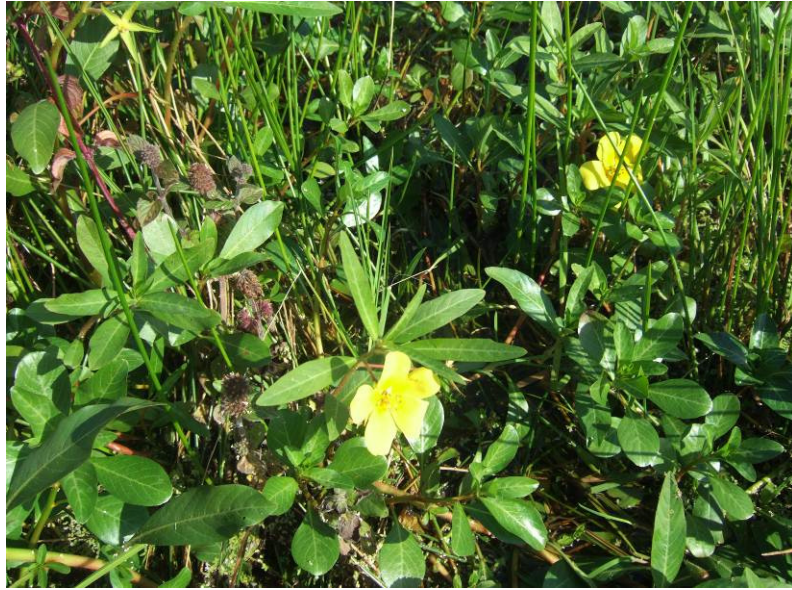
The high water levels in Round Pond during 2012 prevented any herbicide treatment being undertaken that year and allowed the *Ludwigia grandiflora* to grow profusely as shown in this photograph taken on 9 September 2012

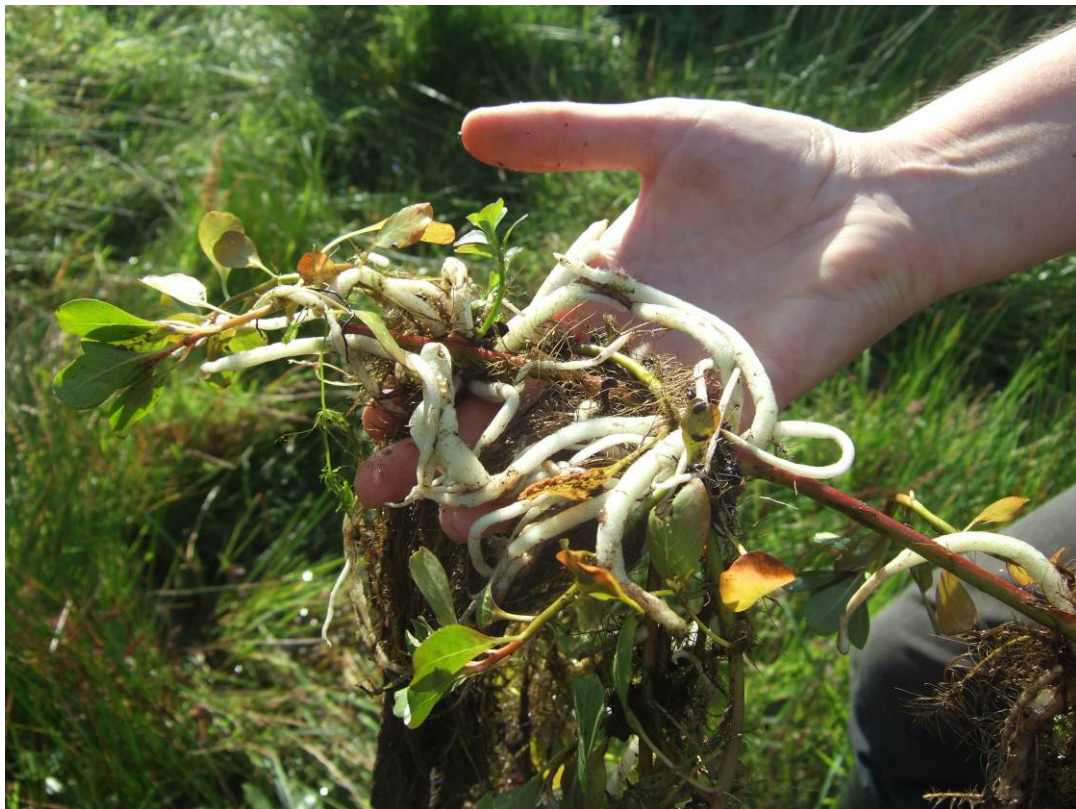
Photograph taken on 9 September 2012 showing a) the white, porous upward-growing aerenchymous roots (pneumatophores) which provide a conduit for atmospheric gases to be transferred throughout the plant in anaerobic conditions and b) the downward-growing adventitious roots (arising from the stem) which absorb nutrients in the water column, often without contact with the substrate.

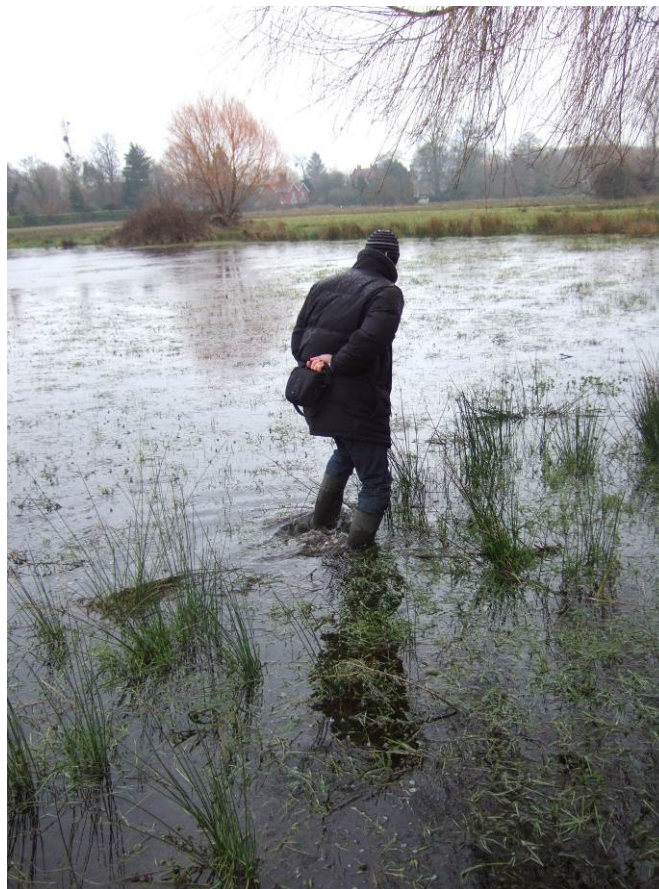
Johan van Valkenburg considering control of creeping water primrose in Round Pond during site visit to Breamore Marsh on 21 March 2013

In the light of his experience, Johan recommended that successful eradication of the creeping water primrose at Breamore Marsh would necessitate dredging Round Pond to a depth of 30cm and disposal of the excavated material.

- continue with herbicide treatment during 2013 (as feasible, depending on water levels in late summer/early autumn 2013);
- investigate feasibility of dredging Round Pond during 2014;
- explore proposals for dredging and disposal of arisings with landowner, local residents and relevant statutory authorities (Natural England, Environment Agency and local planning authority);
- secure necessary permits, authorisations, consents from relevant statutory authorities;
- secure necessary funding.
